**EXECUTIVE SUMMARY**  
**F-15D 85-0131**  
**AIRCRAFT ACCIDENT INVESTIGATION BOARD**  
**NELLIS AIR FORCE BASE, NEVADA**  
**30 July 2008**

**SUMMARY OF FACTS AND STATEMENT OF OPINION**  
**F-15D ACCIDENT**  
**30 July 2008**

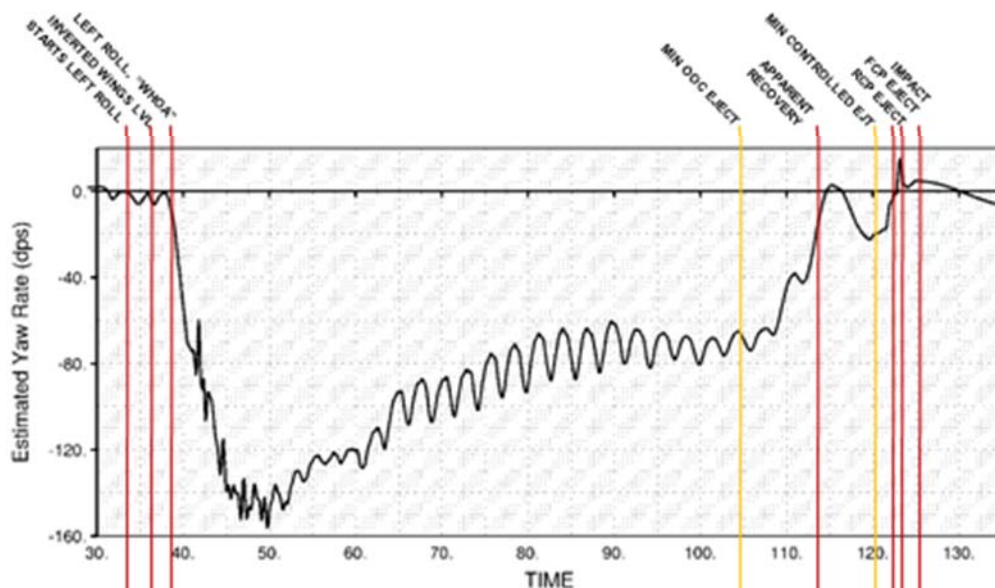
**Figure 2.** Plot of mishap aircraft yaw rate, 1817:00Z thru 1818:36Z (Tab CC-9).

Note: Time 1817:00Z equals 30 on time scale. Time is in seconds. Left yaw is negative.

As the mishap aircraft continued to spin the yaw rate steadily slowed, and then maintained half its peak rate, 46 seconds after the initial departure (Tab M-7). The yaw rate then remained stable for approximately 30 seconds (Tab M-7). As the mishap aircraft passed through approximately 15,000 feet MSL (10,000 feet AGL) the altitude displayed in the SRD began to flash, indicating the mishap aircraft had calculated that it had descended below 10,000 feet AGL (Tab L-3, BB-7). The aircraft’s computer approximated this by using the nearest stored navigation point (5,300 feet MSL) (Tabs AA-6, BB-7). This was the only displayed AGL indication available to the mishap pilot. At 1818:14Z and 12,000 feet MSL, the mishap pilot transmitted, “OK, I’ve got a spin” via the mishap aircraft primary UHF radio (Tab N-8, M-7). Four seconds later, as the
